1. Project Name: Kahului DDH
2. Date of Inspection: August 14, 2007
3. Inspection Personnel:

O & M INSPECTION REPORT FOR NAVIGATION PROJECTS

Honolulu Engineer District

KAHULUI HARBOR, MAUI, HAWAII

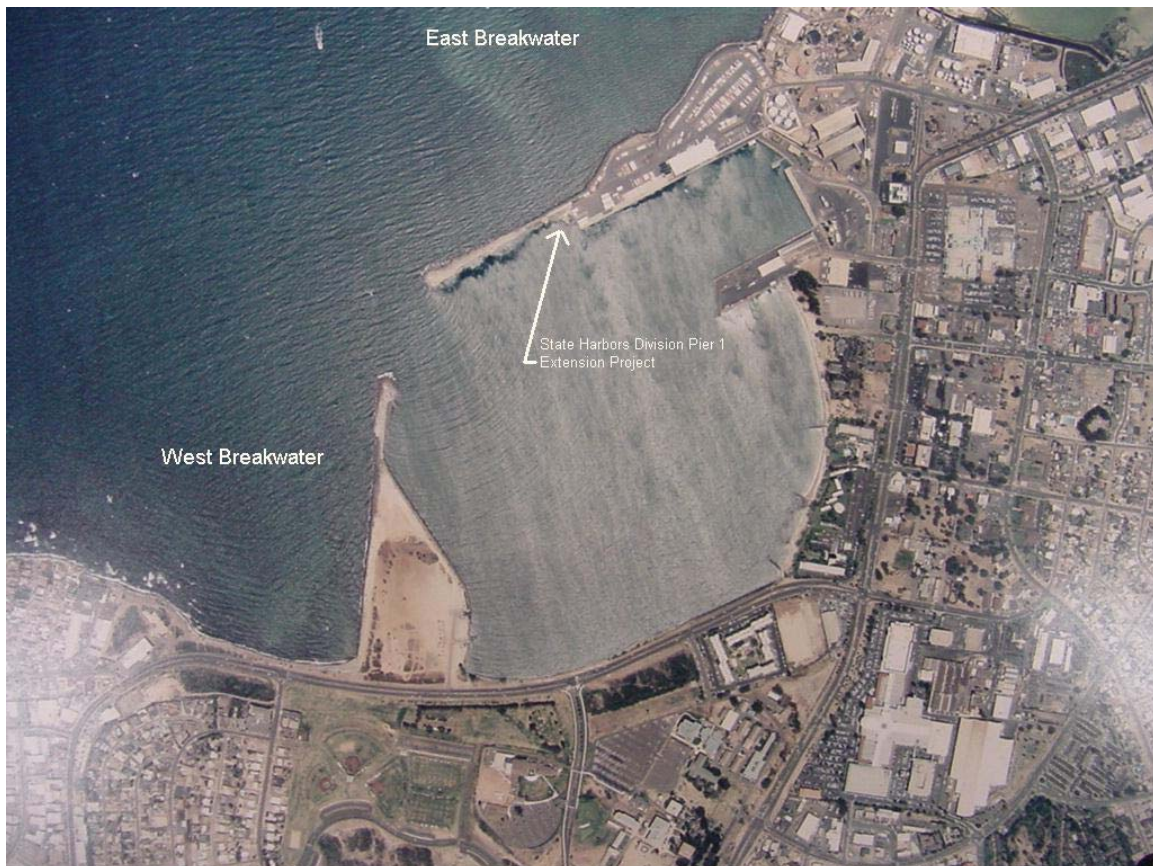
Prior to the inspection I met with Mr. Stephen Pfister, Harbor Master, Kahului DDH, 873-3352. Pfister said the only recent work was the completion of Super Ferry Docks at the harbor. Following the meeting an inspections of the East B/W, and the West B/W were conducted. See photo below:

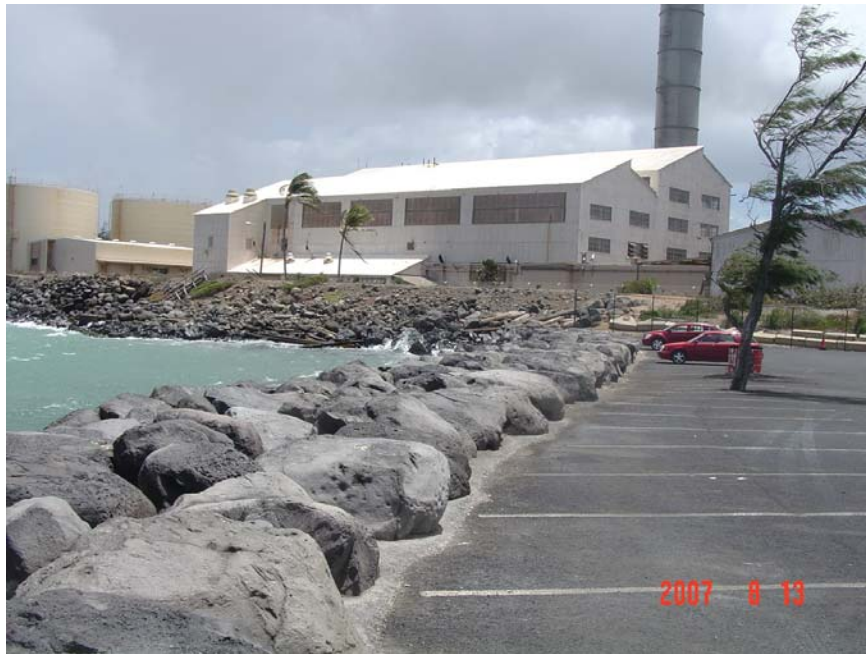
a. Station 0+00, overview.

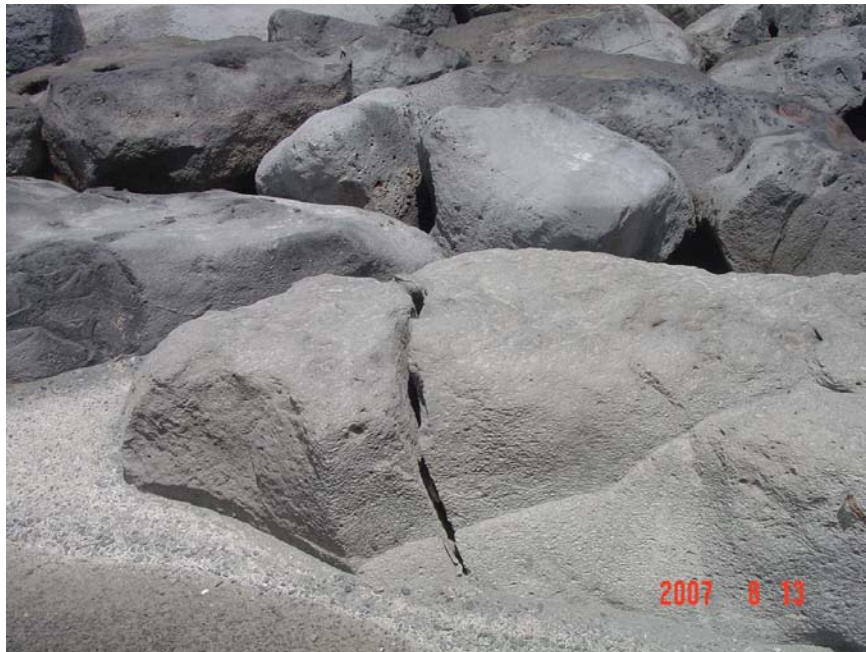
b. Sta 3+08, HS, Cracked armor stone.

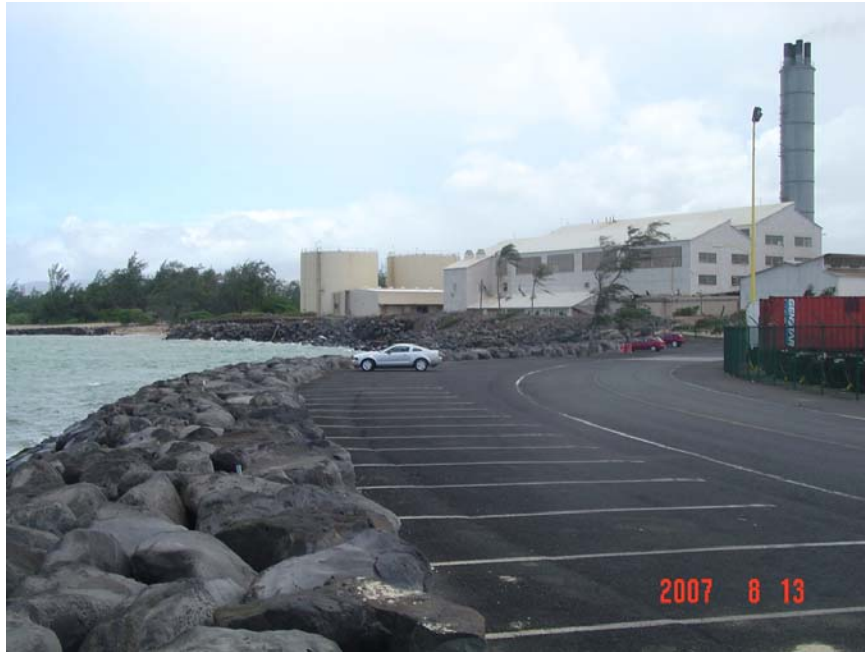
c. Sta 4+90, Lightpole # 15, Overview facing root.

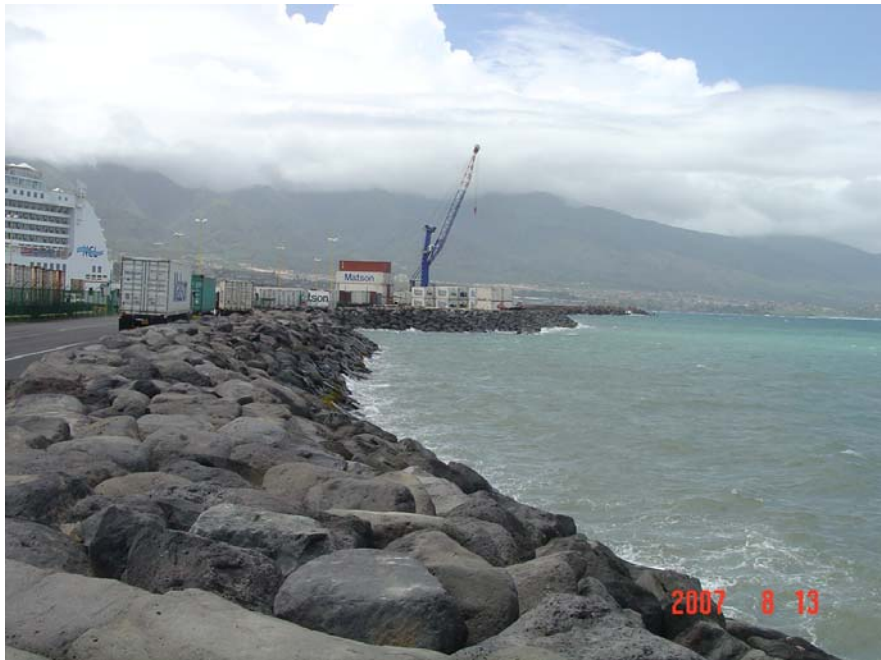
d. Sta 7+44 (Lightpole 12), Overview facing head.

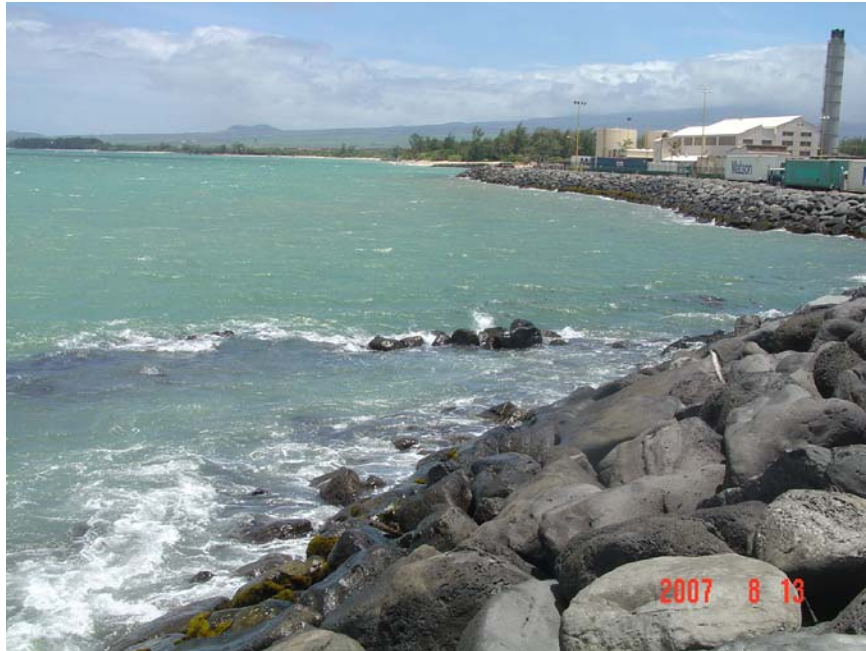
e. Sta 13+43, OS, adjacent stones not from structure.

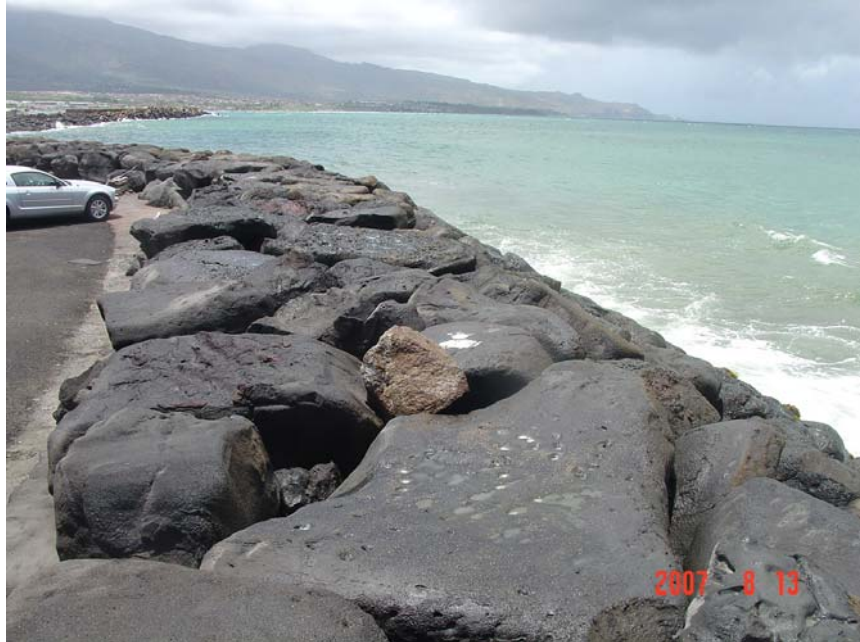
f. Sta 14+90, Bridging of armor stone at crest

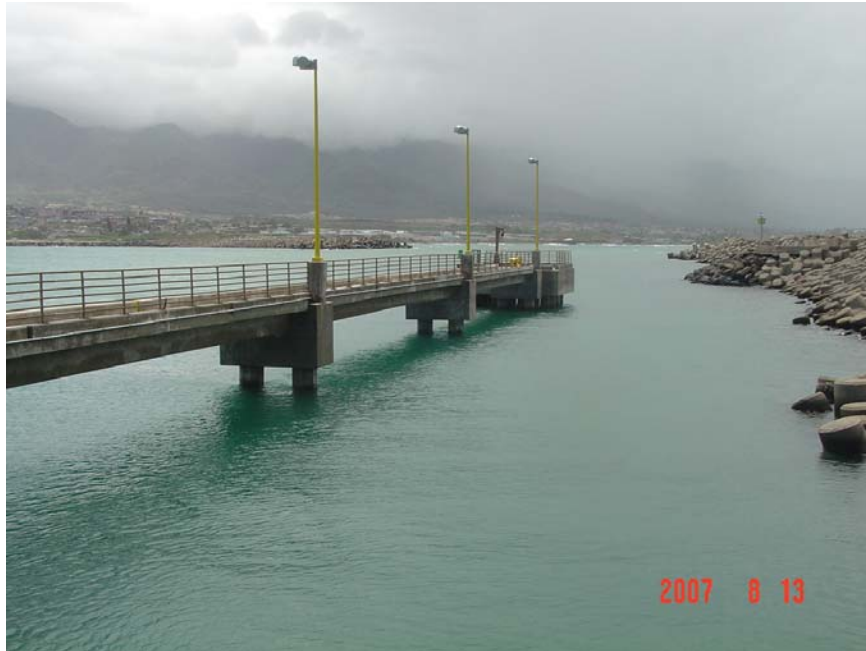
g. Sta. 26+26, HS, New dolphin and walkway adjacent B/W.

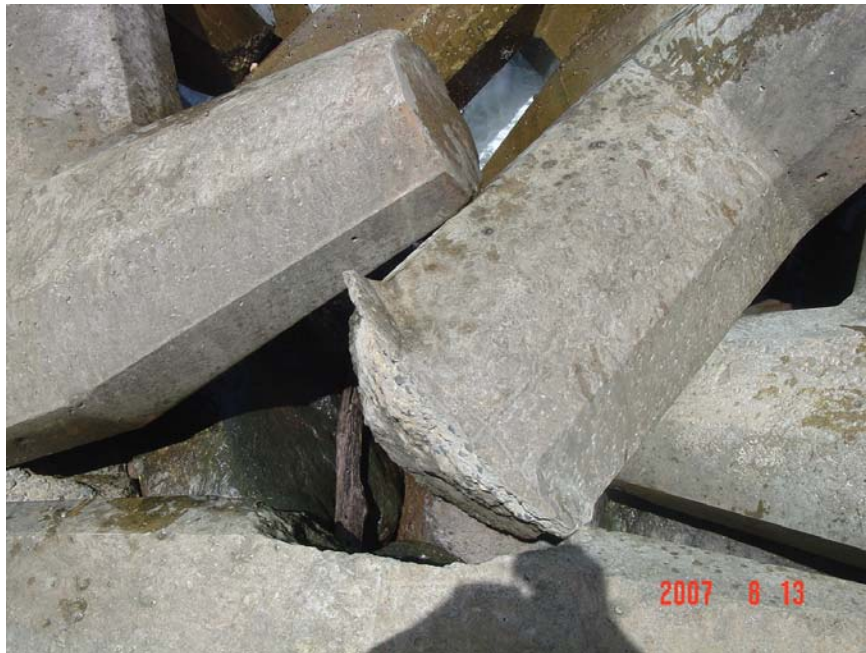
h. Sta 26+92 (Rib 12), Straight shank fluke break.

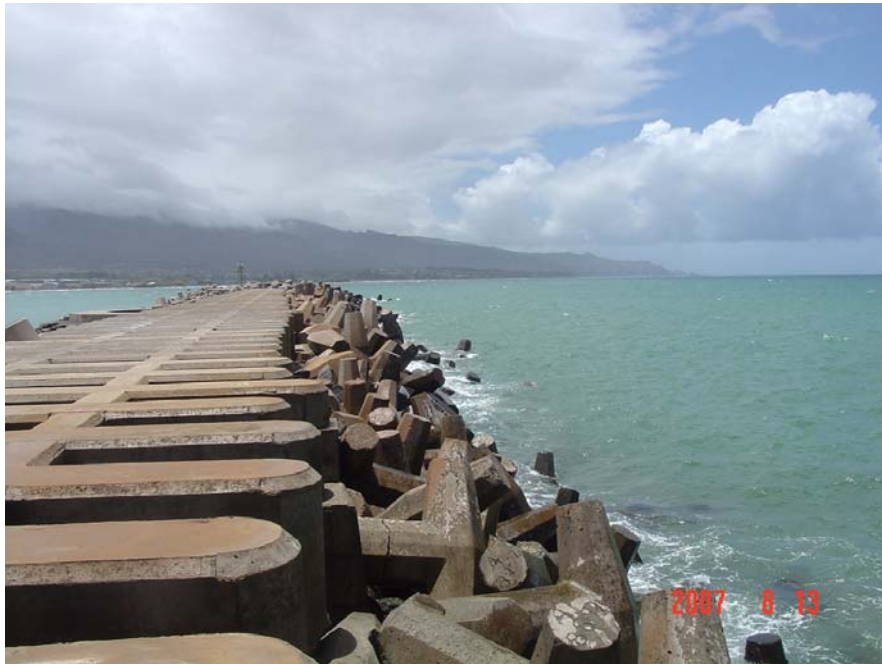
i. Sta 26+30, OS, Overview of steepened side slope.

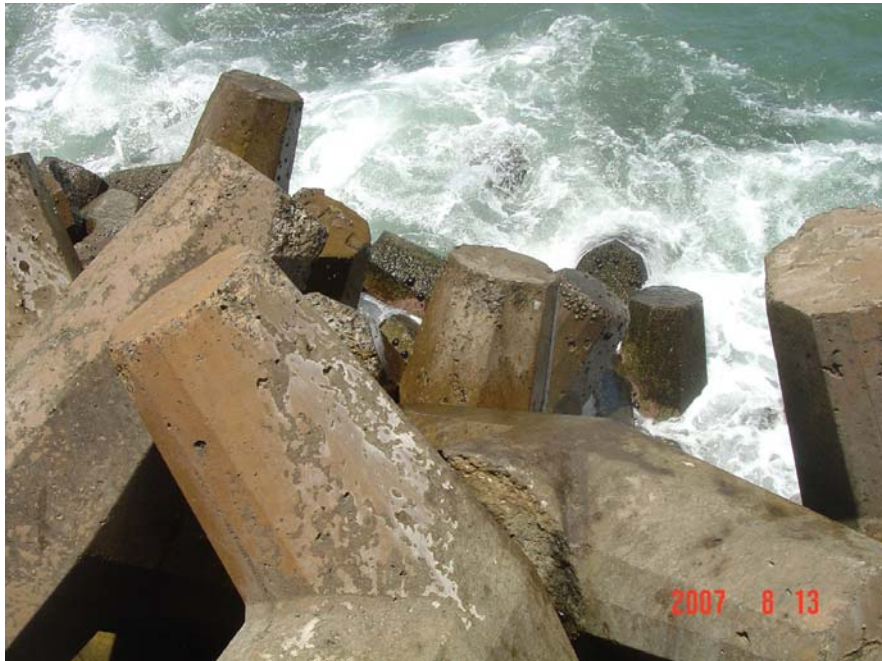
j. Sta. 26+97 (Rib 13), Mid-shank break and shank-fluke break.

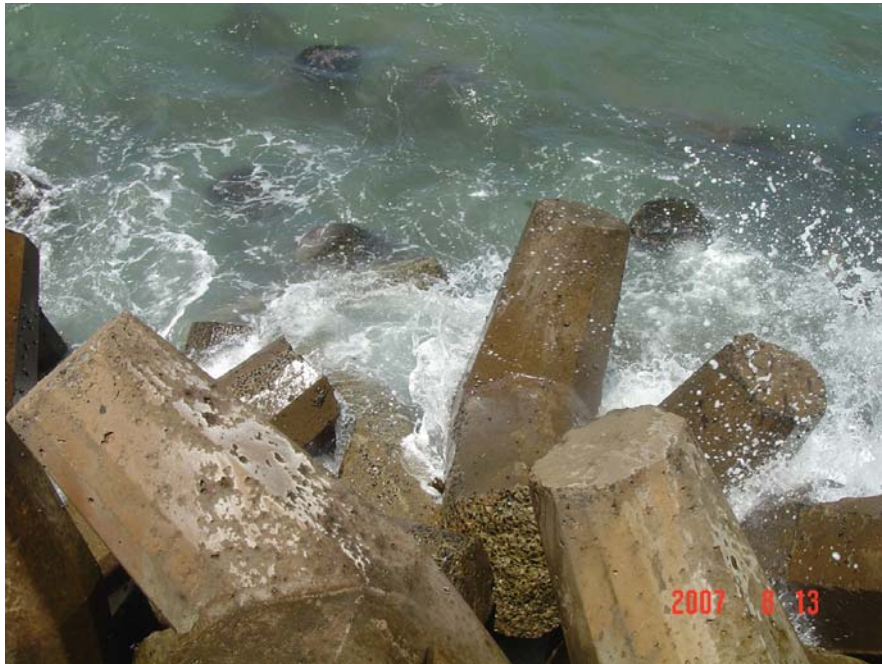
k. Sta 27+09 (Rib 15), Shank-fluke breaks (2 ea.).

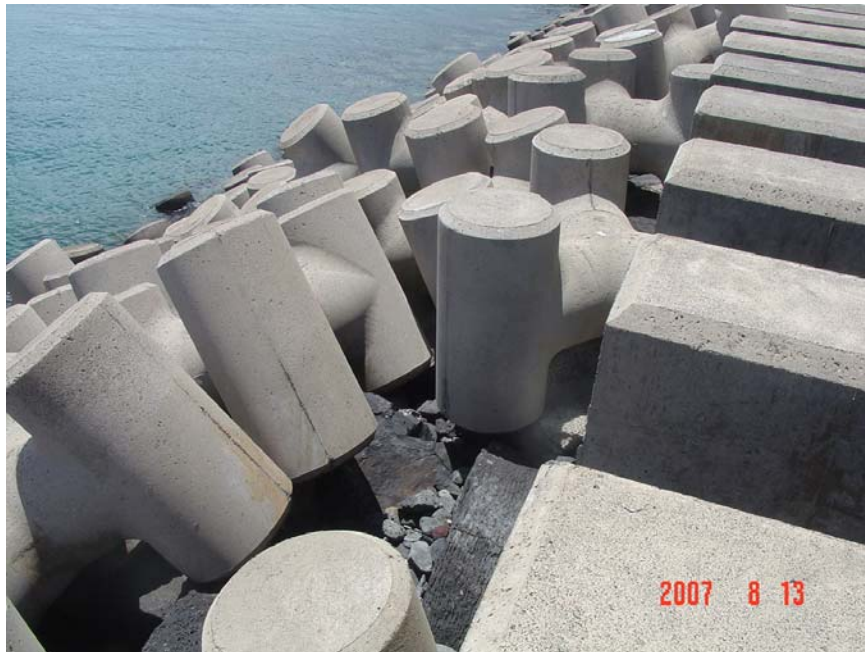
l. Sta. 27+16 (Rib 16), HS, Tribar separation from ribcap.

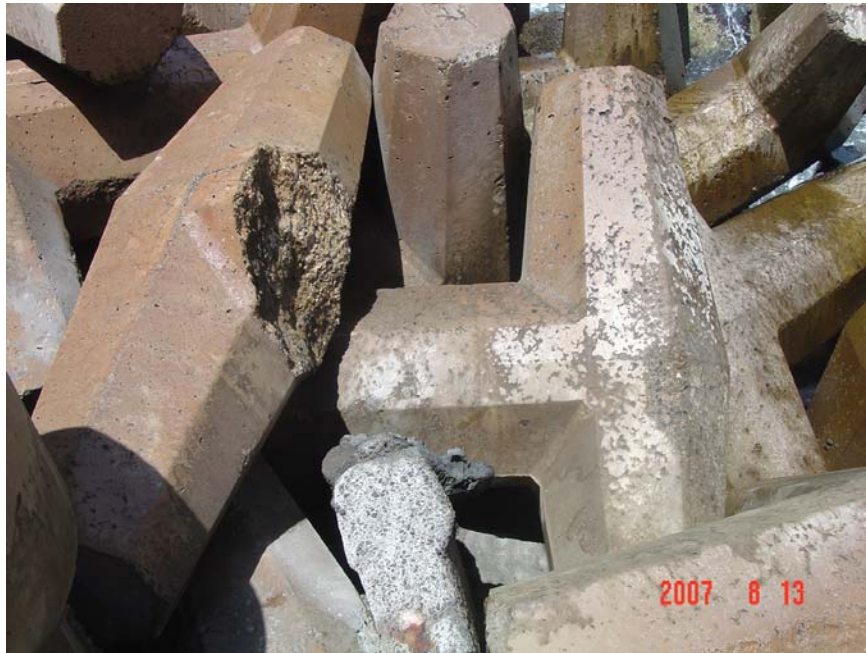
m. Sta. 27+19 (Rib 18), OS, Straight shank fluke break.

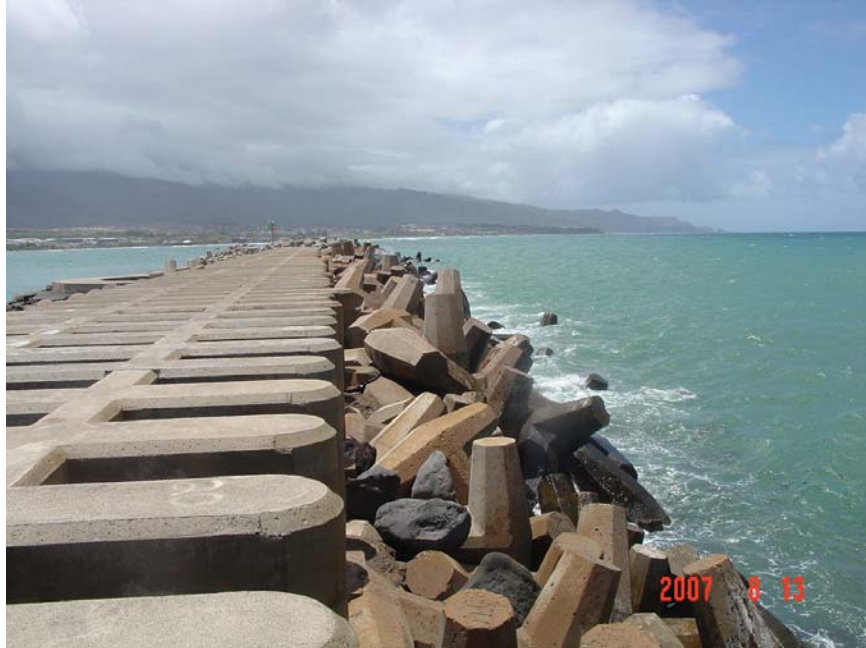
n. Sta 27+19, OS, Overview of side slope.

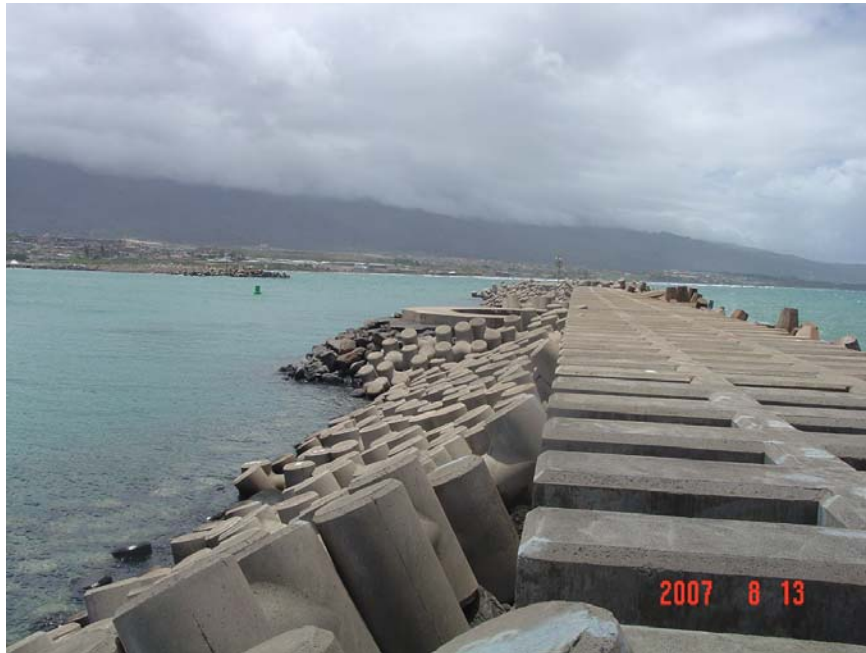
o. Sta 27+51 (Rib 20), HS, Overview and broken tribar.

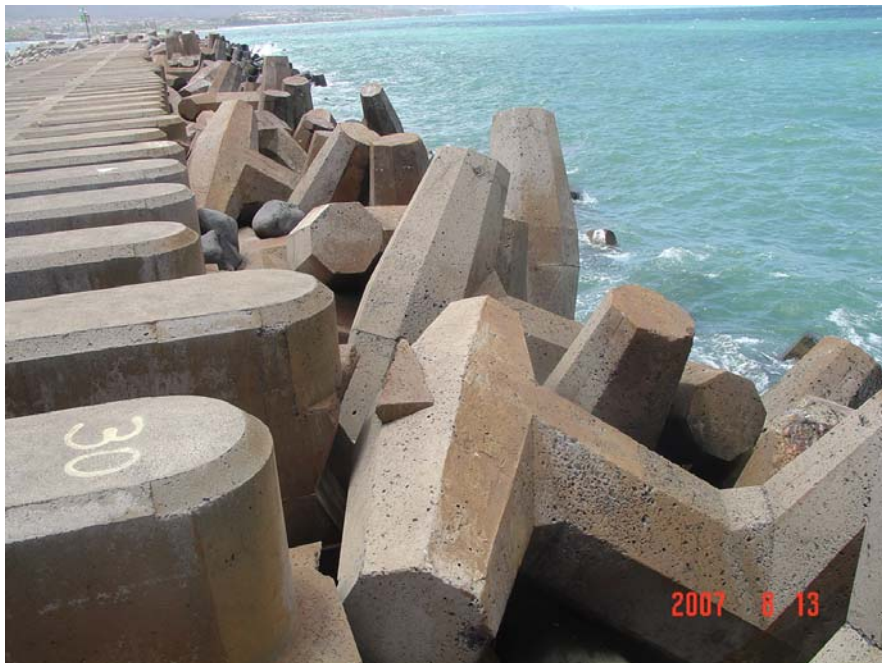
p. Sta 27+69 (Rib 30), OS, three broken dolos.

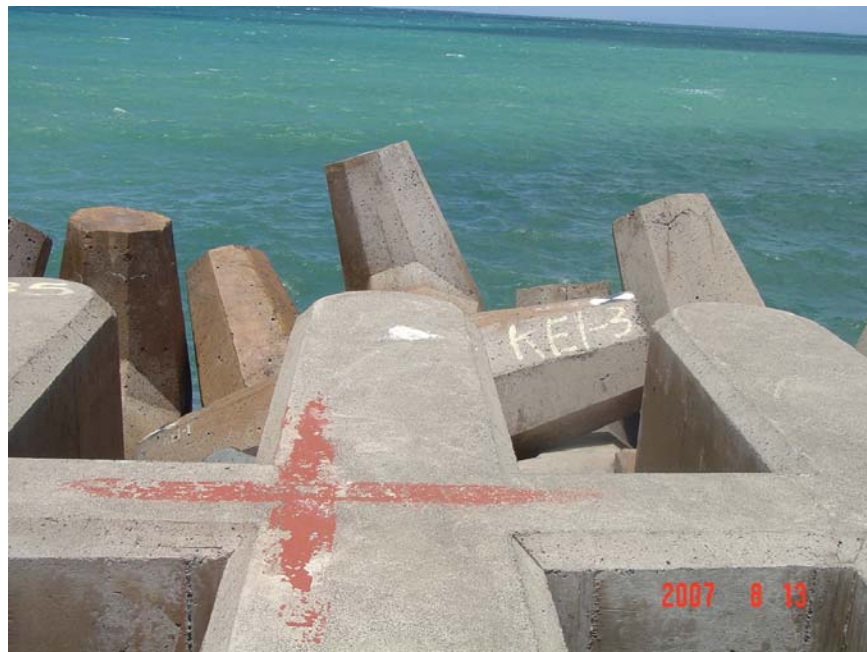
r. Sta 28+28, Rib # 32, Red cross painted.

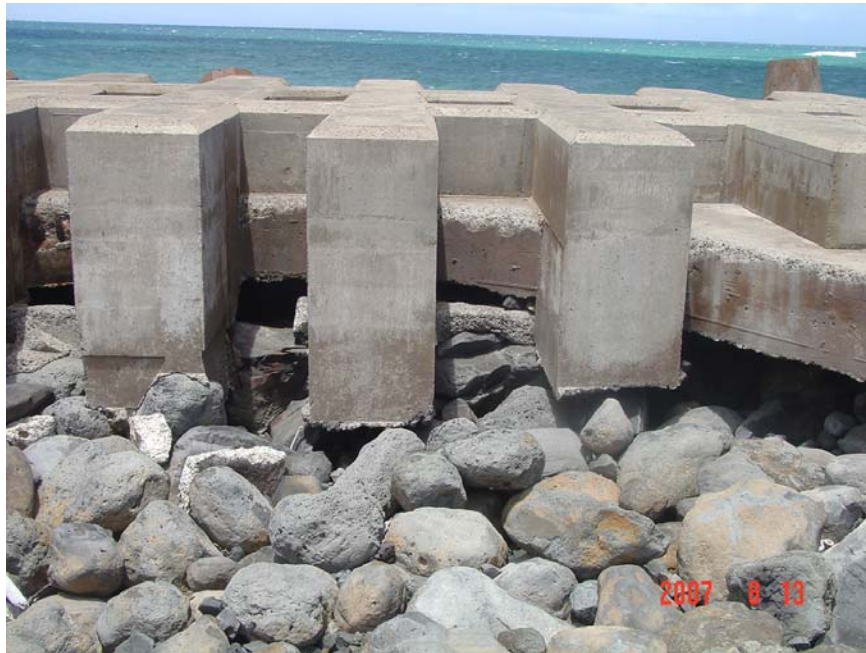
s. Sta 29+27 (Rib 40), Centerline of first turnaround.
Settling of armor stone causing ribcap to be unsupported.

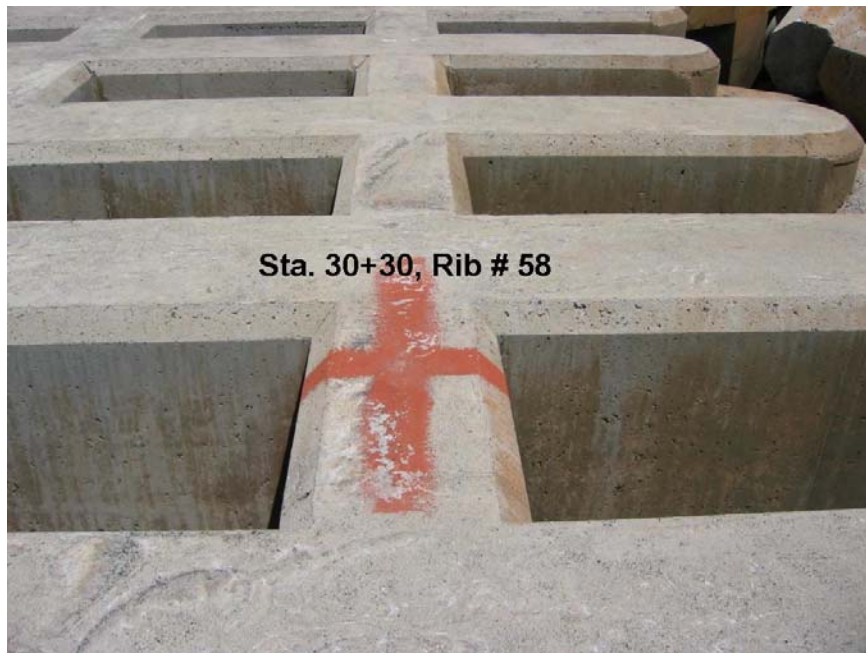
t. Sta 30+30 (Rib 68), Red cross painted.

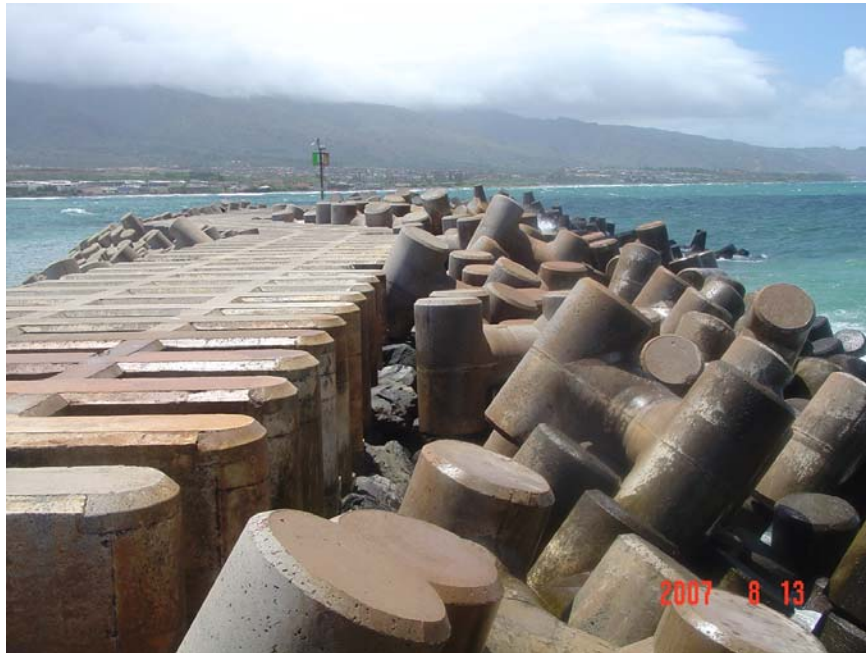
u. Sta 30+97 (Rib 69) to Sta 31+43 (Rib 76), OS, 10 ft Tribar separation from ribcap.

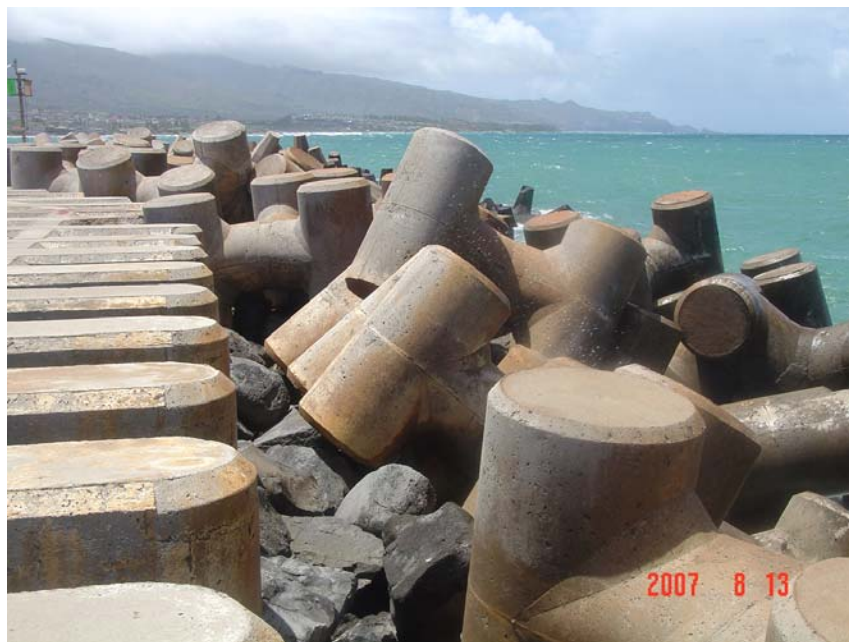
v. Sta 31+50 (Rib 77) to Sta 32+04 (Rib 86), 8 ft Tribar separation from ribcap.

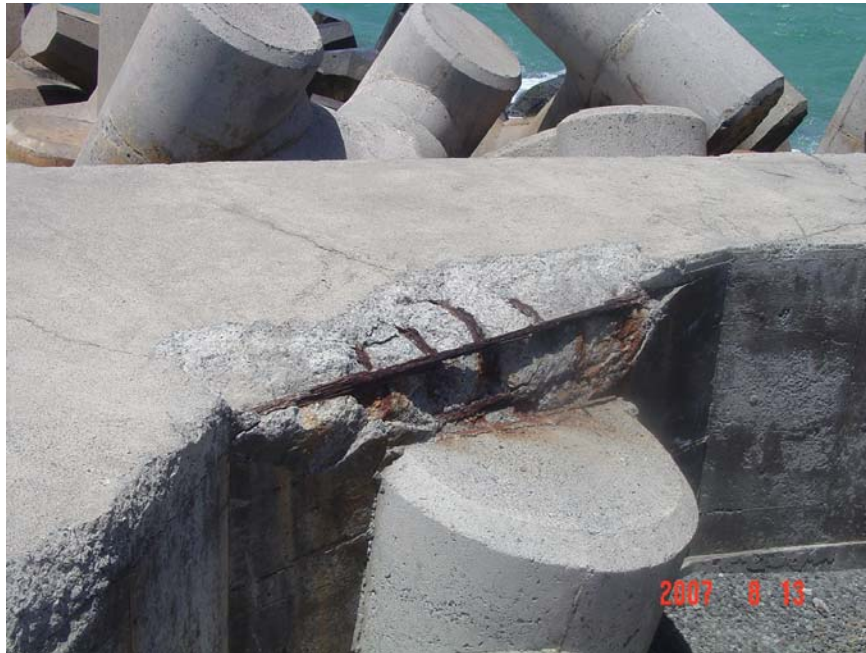
w. Sta 32+16 (Rib 88), OS, Cracked/spalling ribcap, red cross painted.

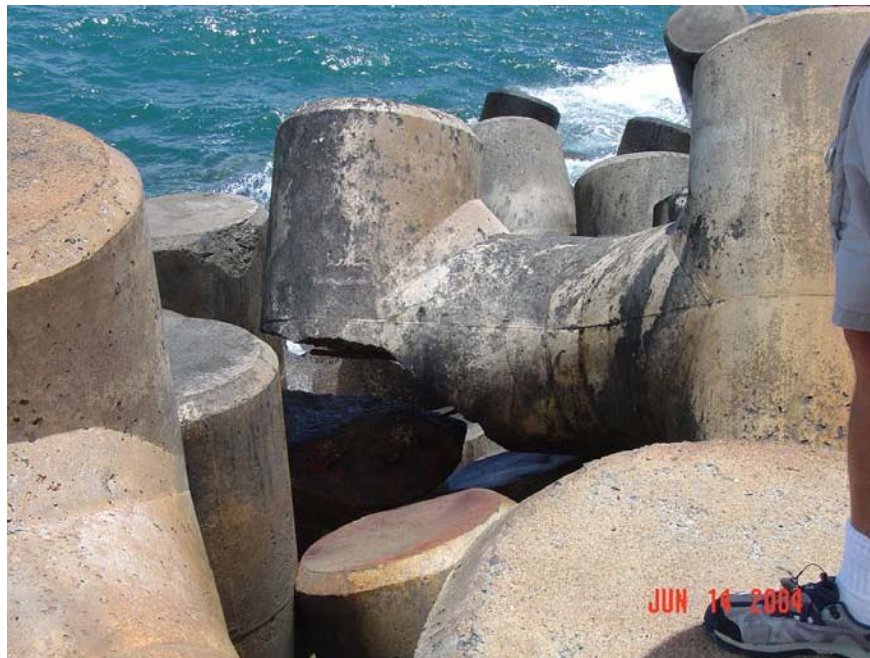
x. Sta 32+85, Broken tribar leg.

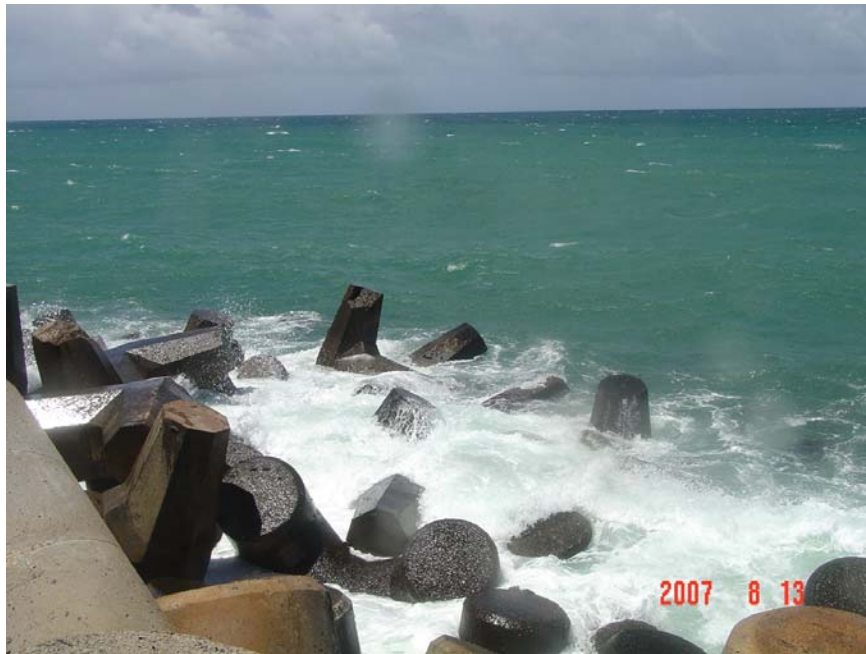
y. Sta 33+78 (Rib 104), OS, Angle shank-fluke break.

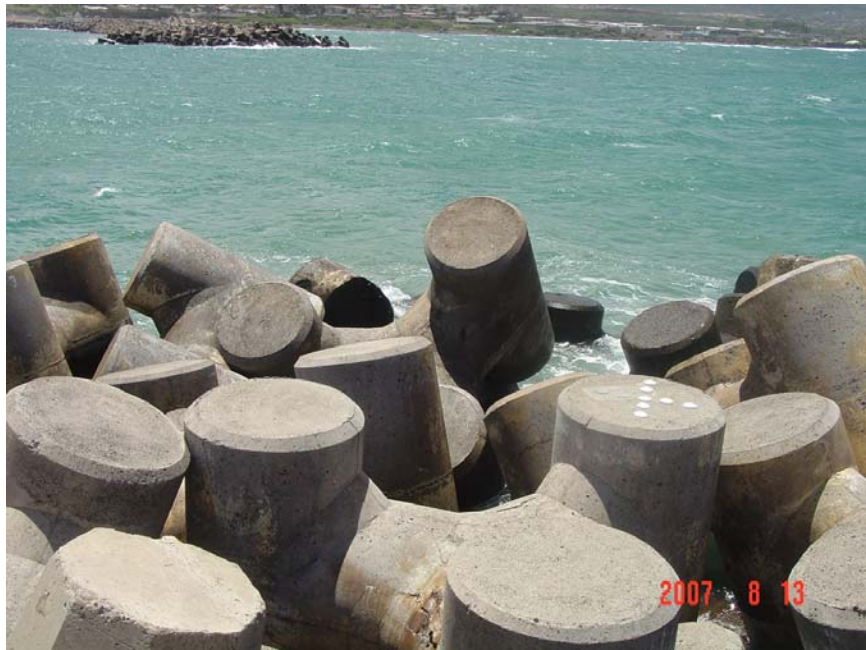
z. Sta 34+62, HS, Broken tribar.

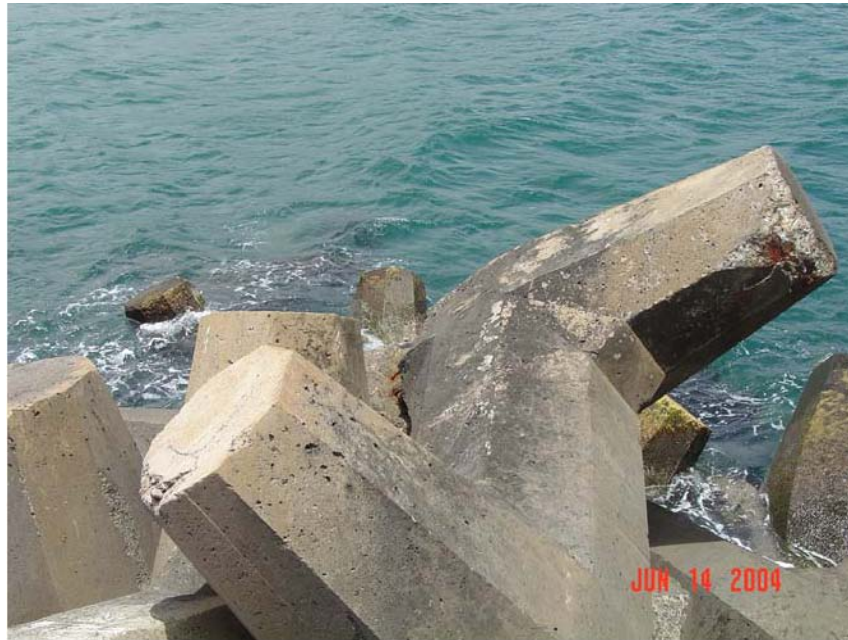
aa. Sta 35+02, Straight shank-fluke break.

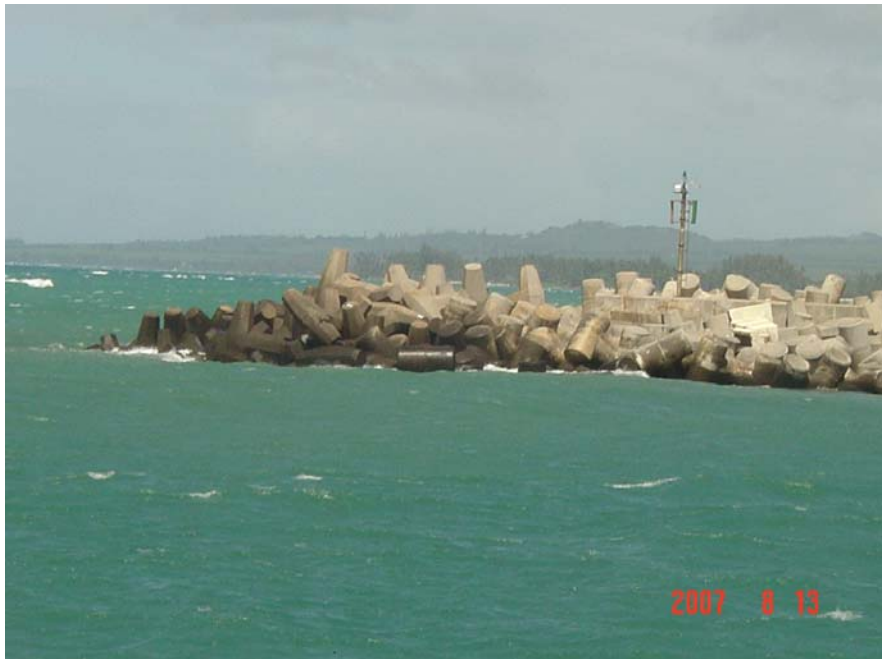
bb. View of East Breakwater head.

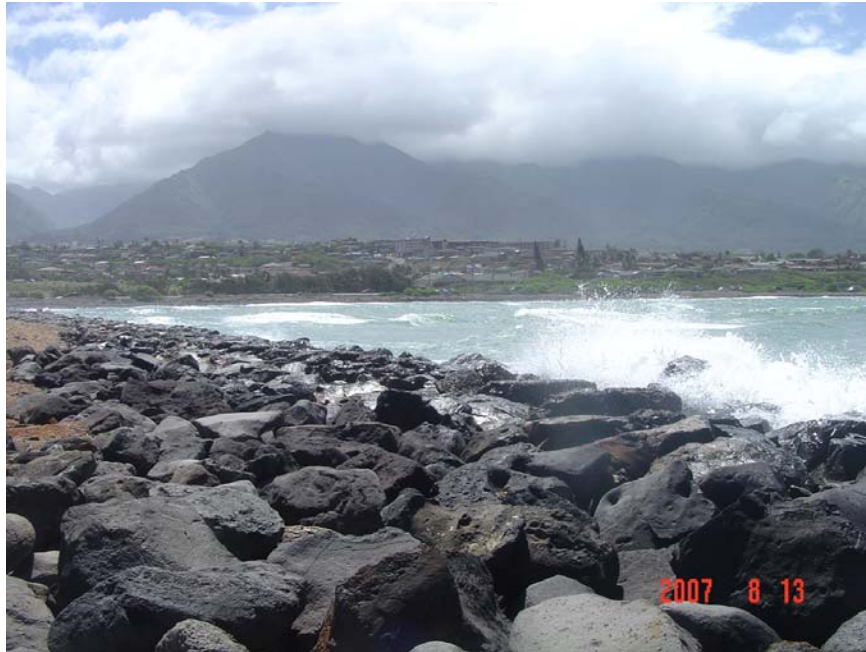
a. Sta 9+70, Overview of structure and displaced small stones.

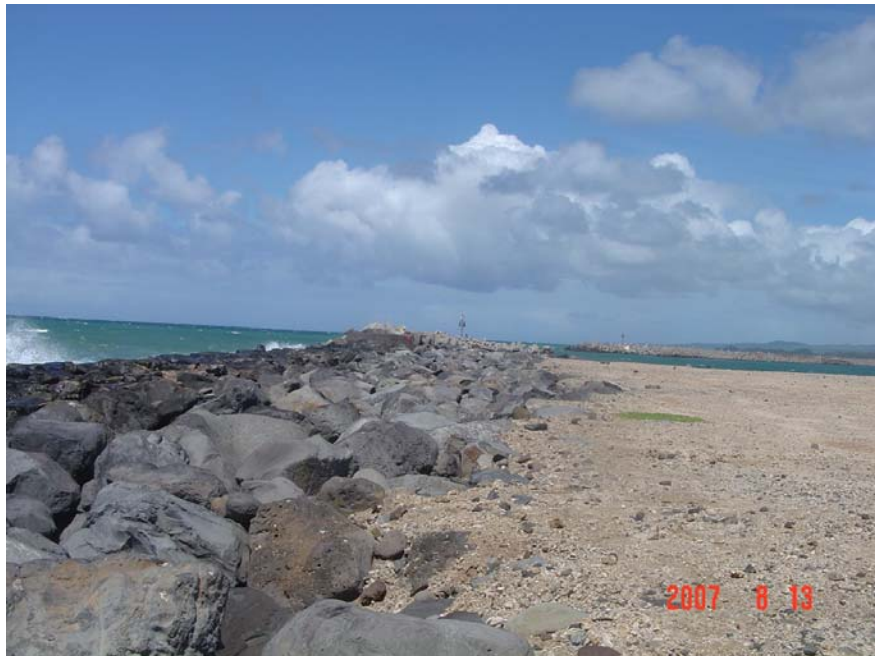
b. Tribar washed back from trunk of structure.

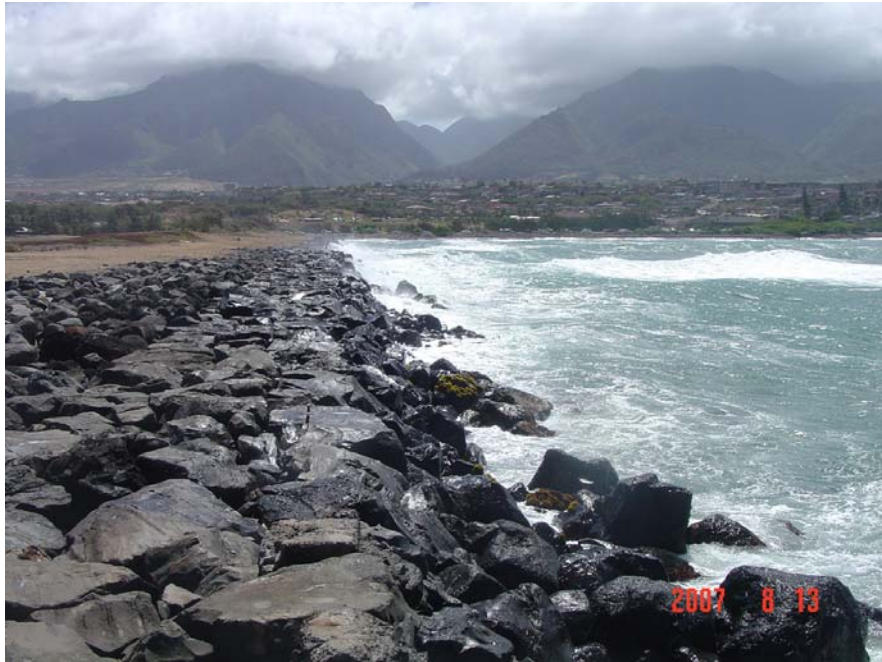
c. Sta 17+41, OS, Sideslope steepening, monitor armor stones adjacent to toe.

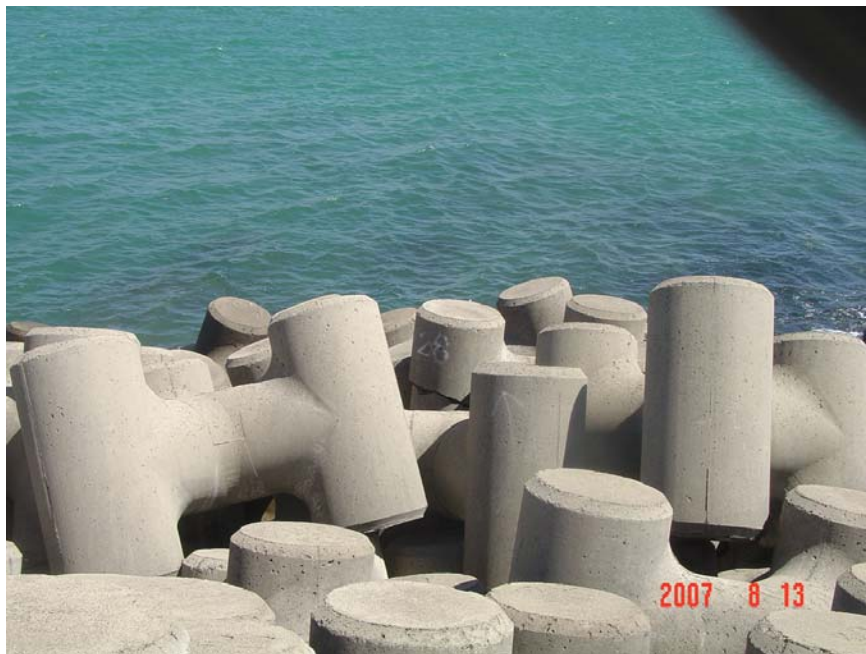
d. Sta 17+85 (Rib 6), HS, Broken tribar.

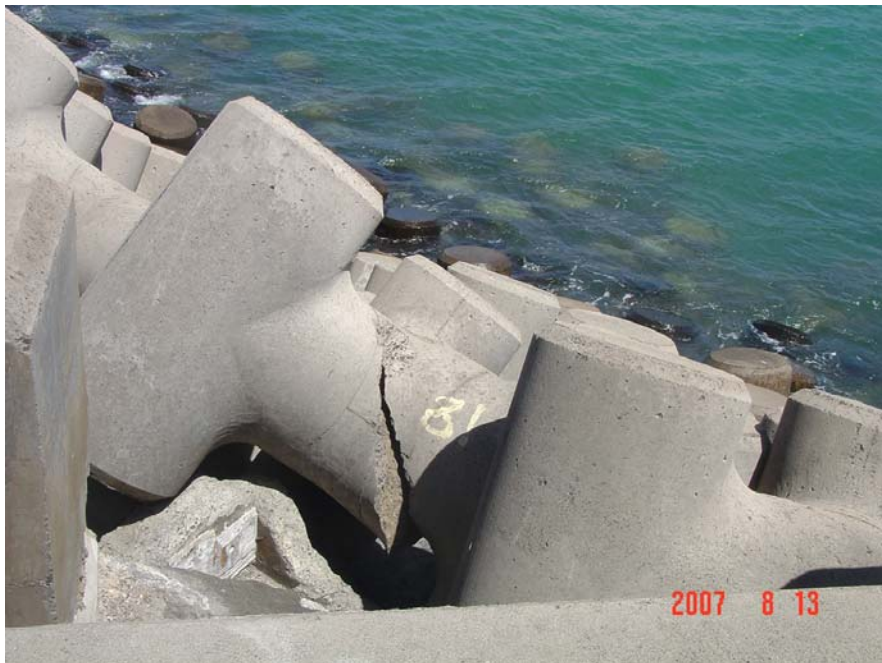
e. Sta. 18+50, HS, Broken tribar, no change this year.

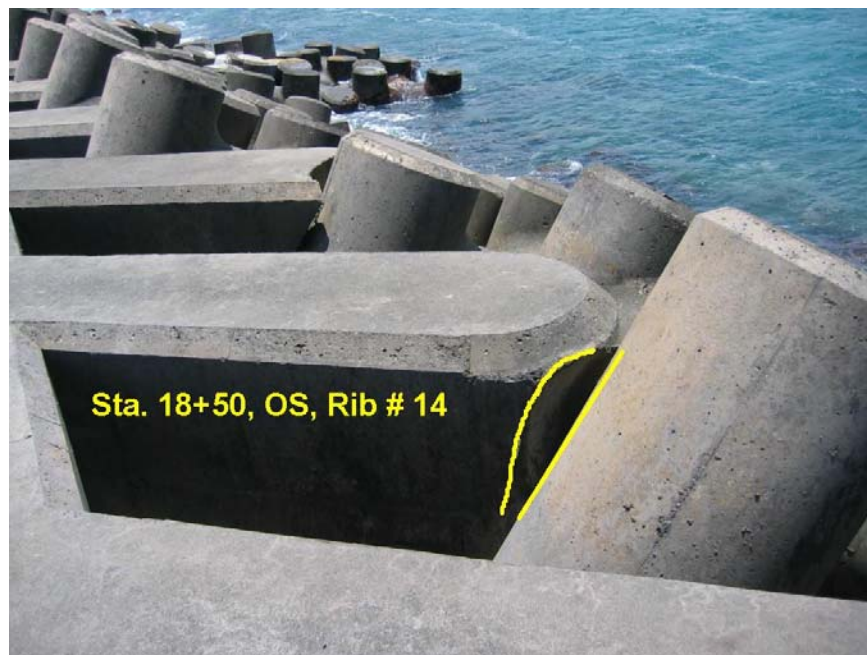
f. Sta 18+50 (Rib 14), OS, 8" separation of tribar from RC.

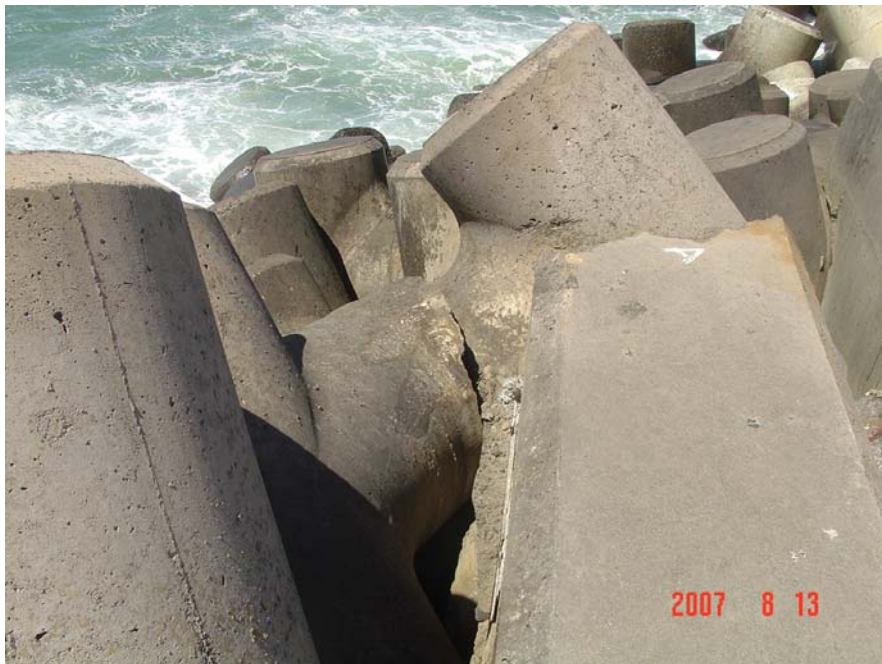
g. Sta 19+00 (Rib 18), OS, 4" separation and broken tribar.

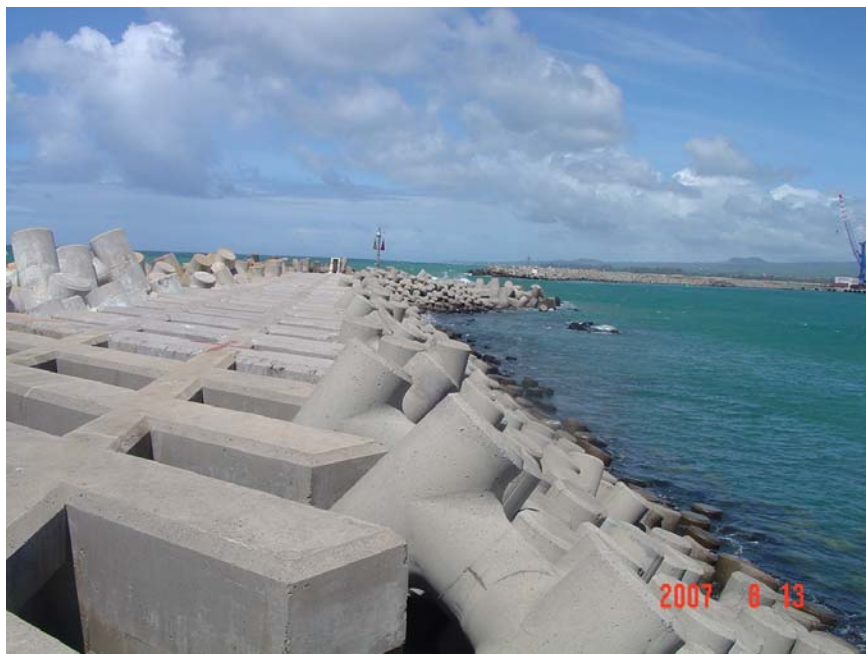
h. Sta 19+00 (Rib 18), HS, Overview.

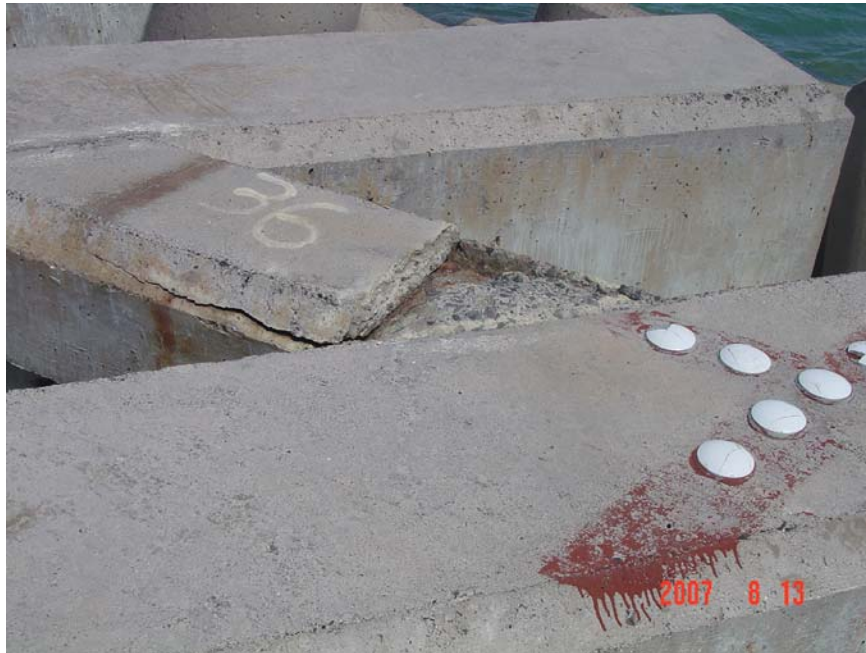
i. Sta 19+41 (Rib 36), Red cross painted and ribcap spalling.

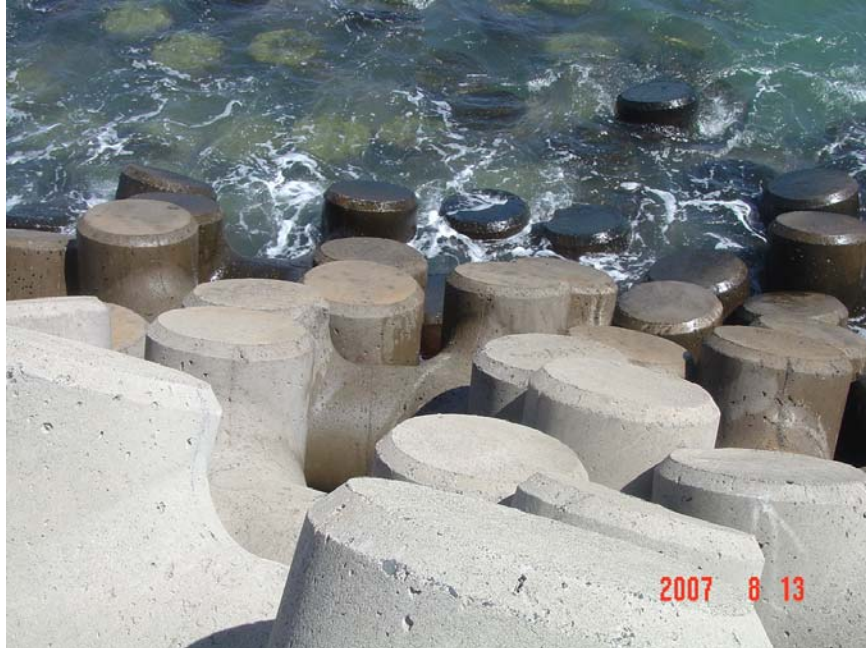
j. Sta 20+87 (Rib 40), HS, Cracked tribar.

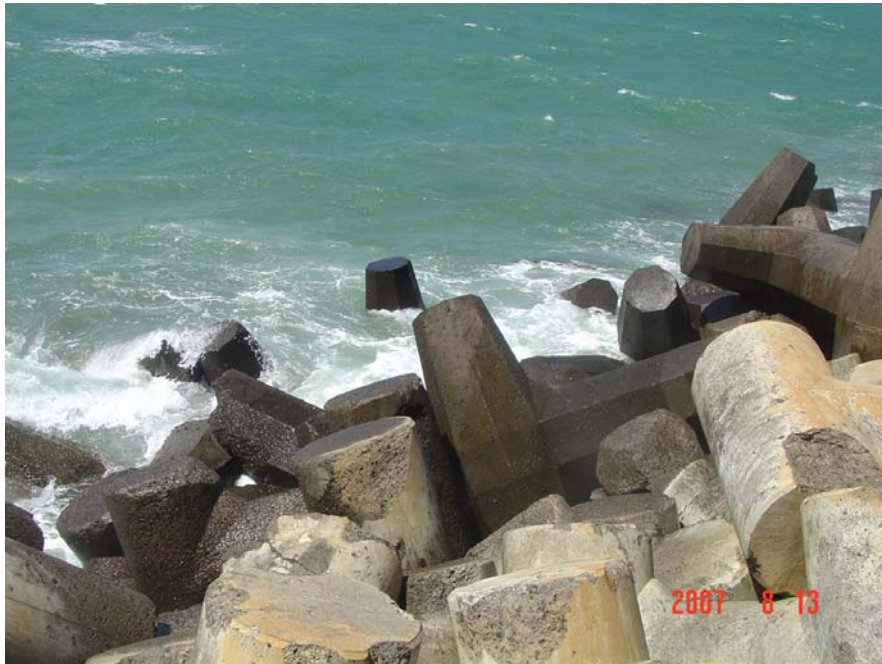
k. Sta 21+42 (Rib 44), OS, Broken tribar.
